Thank you for the opportunity to provide a Consulting Arborist historic tree health assessment for the Creek Crossing Development. This report includes an assessment and picture of each historic tree.

CREEK CROSSING - HISTORIC TREES

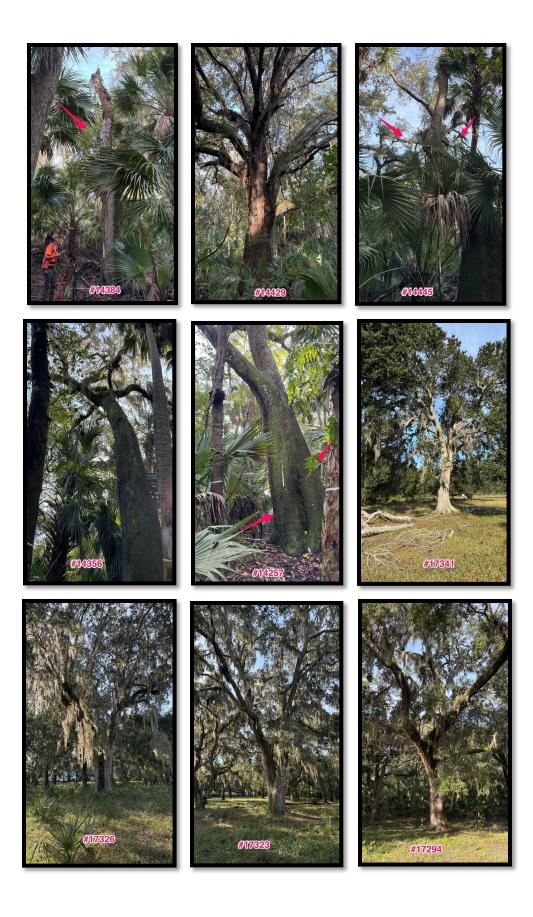
Right - picture right number should be #18068

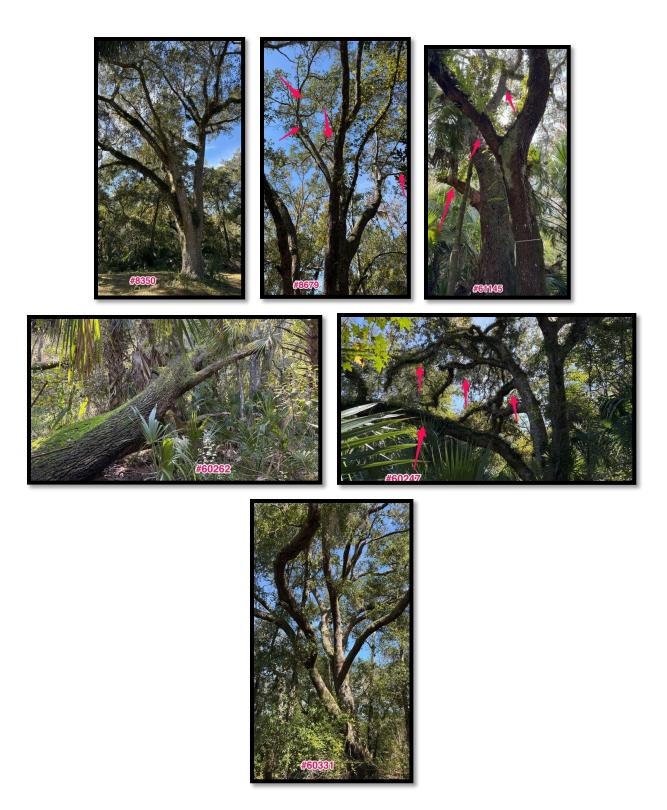
Right - picture right number should be #17829
