B-21 Watershed Management Plan

County of Volusia

ECT No. 08-0456

August 2009

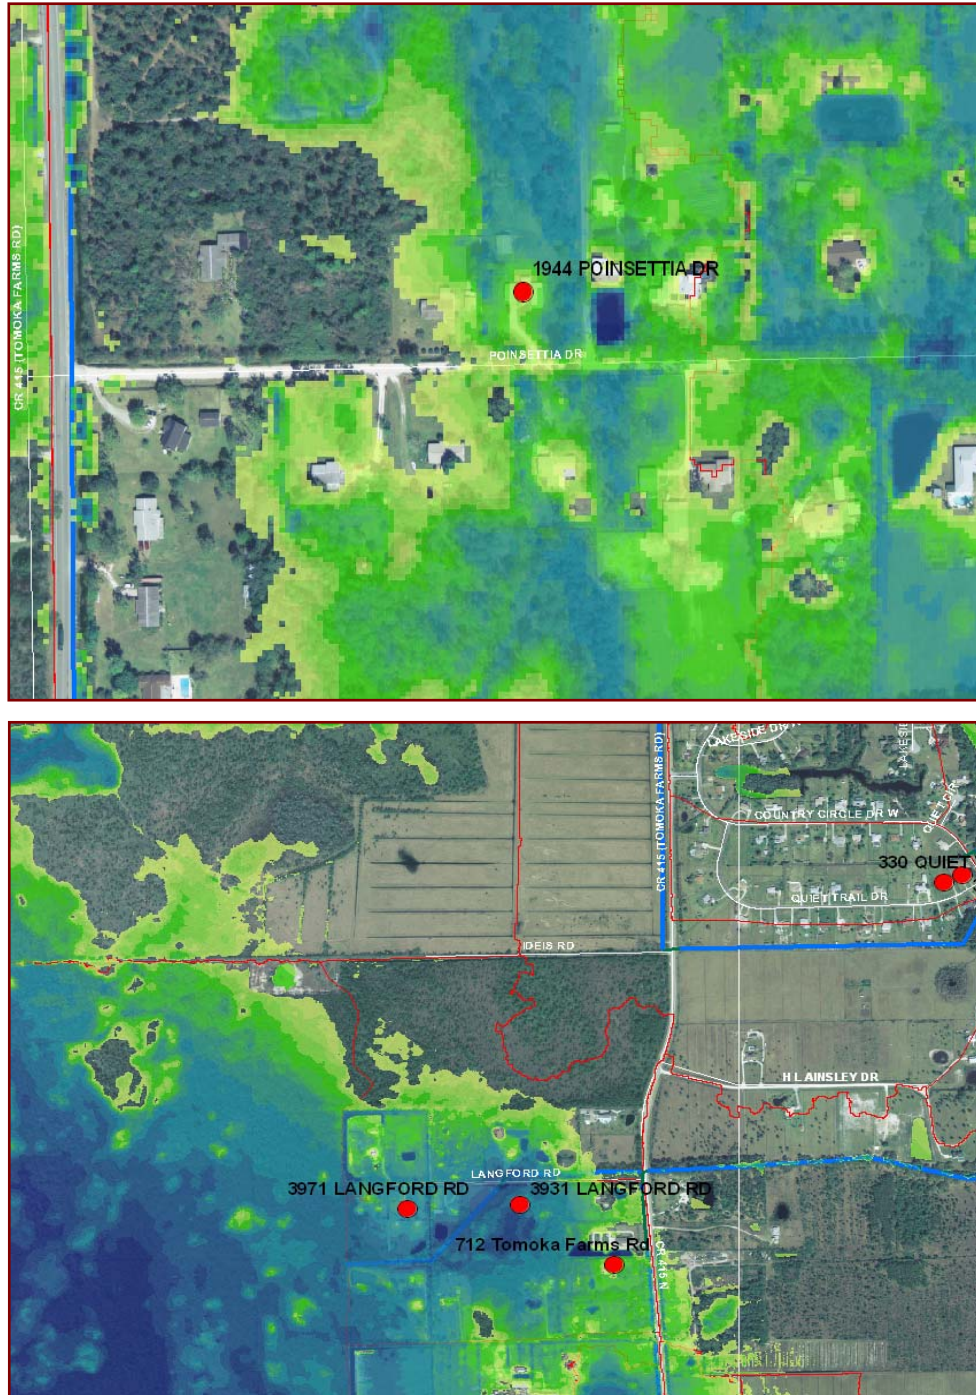
Figure 3-7 (a). Examples compare model results and public problems reported for T. S. Fay (2008). (Upper) House at 1944 Poinsettia Drive is flooded. (Down) Langford Road and surrounding properties are flooded.

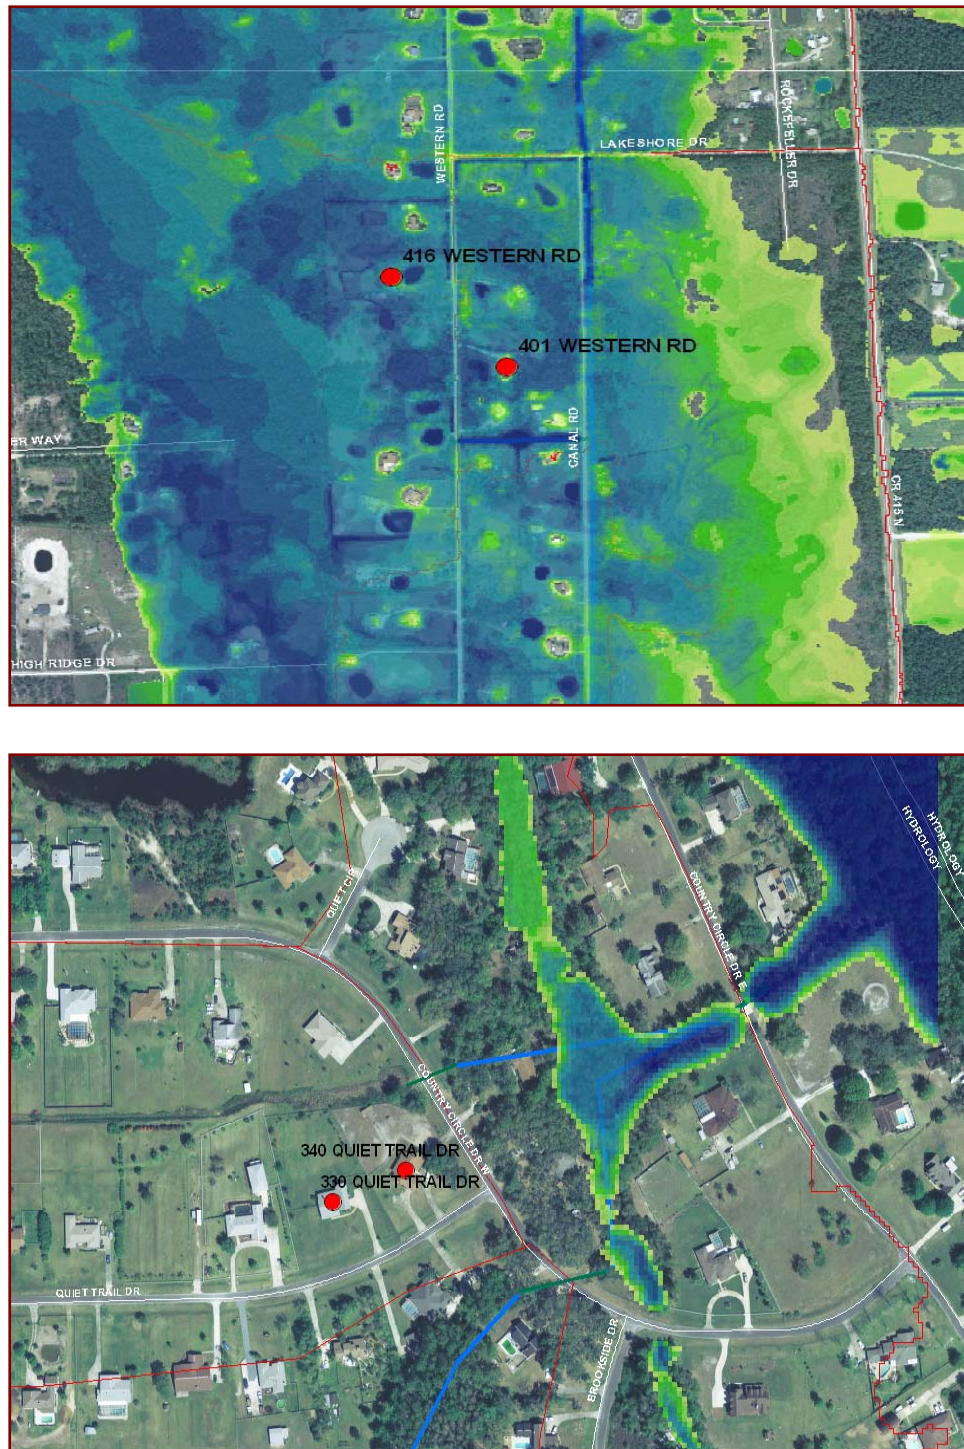
Figure 3-7 (b). Examples compare model results and public problems reported for T. S. Fay (2008). (Upper) Properties on Western Road are flooded. (Down) No water on Quiet Trail Drive and surrounding lots.
